WHAT WE KNOW ABOUT THE COURSE OF THE SMOLENSK CATASTROPHE.

THE SMOLENSK CONFERENCES - A PRELIMINARY SUMMARY

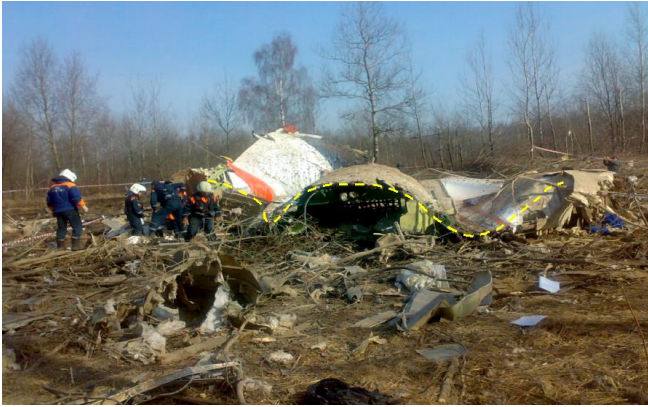
Fig. 3. The central part of the fuselage: from rung 40 till rung 64 [5]. The tear along the fuselage as well as the sides and the ceiling of the aircraft, that are flanged and thrown out, witness about a huge internal explosion. This kind of destruction cannot result from any external forces.

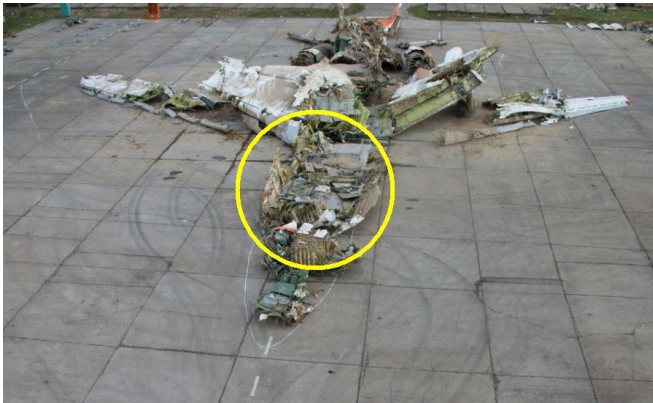
Fig. 4. The Tu-154M wreckage in the Smolensk airport [6]. It is evident, even after cutting off the ceiling as well as a large part of the sides, that the fuselage has been torn.

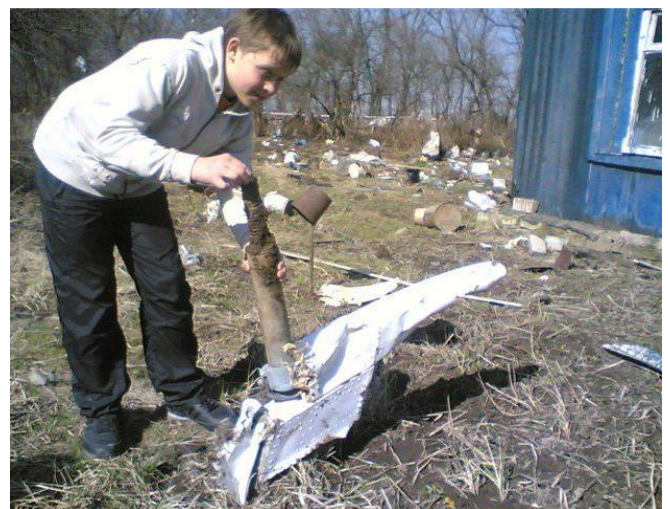
A large number of the fragments of various size are located within the terrain about the Bodin property. The fragments are located before the Bodin birch (the first fragments found 40 m before the birch [10]), around the birch and behind the birch. These are the fragments of the rear and of the central parts of the left wing, which excludes the thesis that they have been created by hitting the terrain obstacles, Fig. 13

Fig. 13. The drive of the left wing outer flap with a part of the flap found at the foot of the Bodin birch [11].

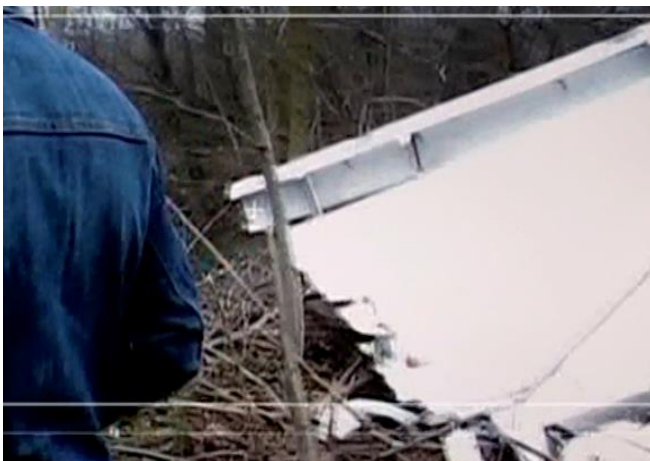
The tip of the left wing has been found in this zone. Also, within the radius of about 10 m from the wing, there are several metallic fragments of the plane, of various size [12]. This photograph (Fig. 15), taken short after the Catastrophe, **excludes the possibility of shearing off the tip due to a terrain obstacle**, instead it suggests damage from a detonation strap.

Fig. 15. The breakthrough of the tip of the left wing. Photo taken within the first hour after the Catastrophe. It comes from the movie "Anatomy of a downfall" [13]. One can see the non-dented wing slot, i.e. its front part, and particularly even cutting of the wing surface.

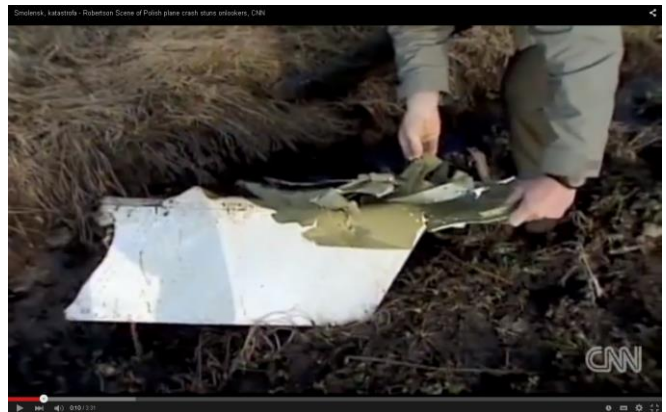
Fig. 16. Zone 3. A CNN journalist Nic Robertson demonstrates a large fragment of the plane's shell [14].

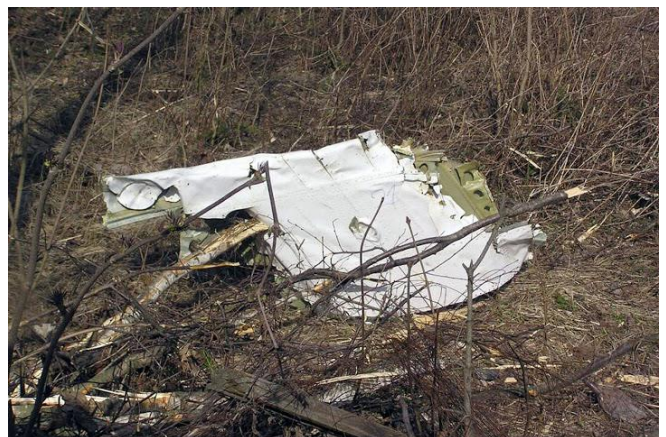
Fig. 17. A large size fragment of the airplane shell found on the Kutuzow Street roadside [15].

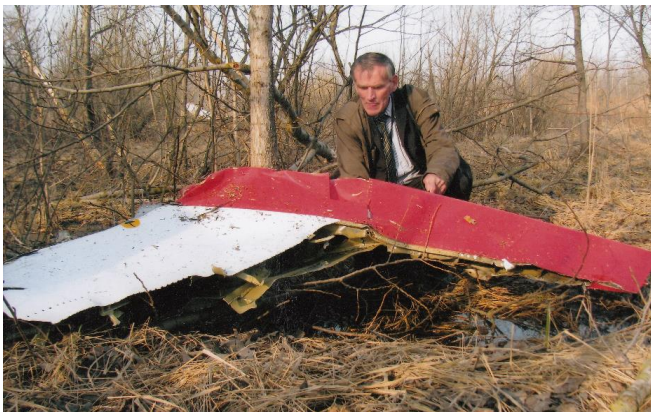
Fig. 18. A fragment of the left horizontal stabilizer lying in the woods about 5 meters from the Kutuzov Street. In the background, behind the trees, one can see the entire dart of the plane. Photo by Jan Gruszyński. Deformation of the detached parts excludes that detachment was due to a collision with a terrain obstacle.

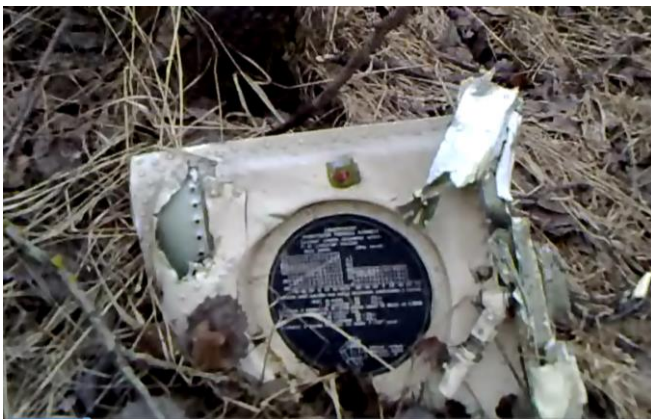
Fig. 19. A fragment of the main landing gear shock-absorber lying among the trees in zone 4 [16].

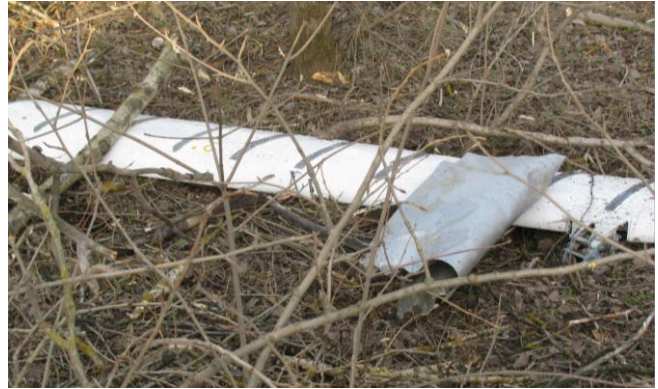
Fig. 20. The interceptor (deflector) of the left wing lying in the woods about 10 meters from the Kutuzov Street. On top a fragment of the slot is visible. Photo by Jan Gruszyński.

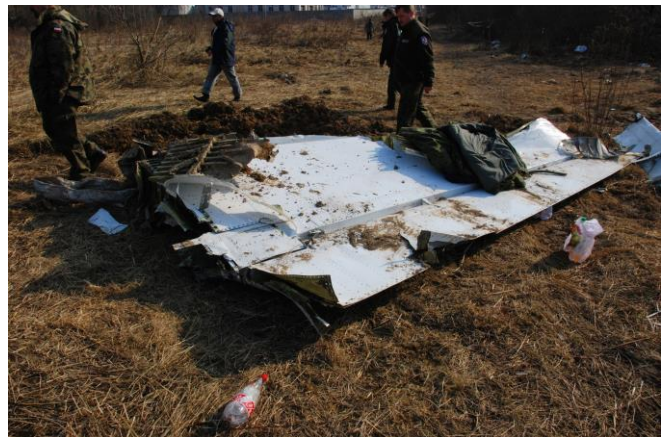
In this zone the rear part of the left horizontal stabilizer lies alone, the elevator being visible (Fig. 21). **The very fact that this is the back, not the front, part, excludes a collision with a terrain obstacle as a possible cause.** On April 11, 2010 this horizontal stabilizer has been transported by Russian soldiers by a distance of several dozen meters to the west, behind the first groove in the ground - the alleged first contact with the ground. This was to make an impression that the detachment of the stabilizer resulted from the ground contact.

Fig. 21. Zone B5. The rear part of the left horizontal stabilizer (with the left elevator) [17].

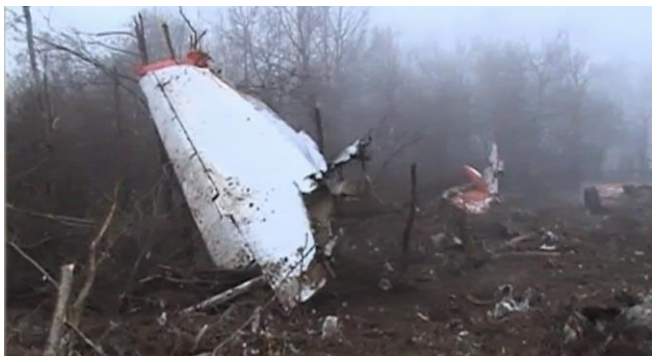
In this zone the right horizontal stabilizer with the elevator has been found (Fig. 22). Note breaking of its bottom and the detachment of its fragment in the direction of the flight, that is, opposite to the force that would be expected at a collision with an obstacle.

Fig. 22. The bottom surface of the terminal part of the right-hand-side horizontal stabilizer with the elevator. The leading edge is to the right. The lower part of the stabilizer lacks a fragment, that was detached in the direction of the flight [18].

Another explosion tore a large part of the right horizontal stabilizer with the aileron (Fig. 22). This part has been found about 30 meters (zone B6 in Fig. 14) before two longitudinal grooves in the ground. The grooves have been indicated in the MAK/Miller hypothesis as the first traces of the plane hitting the ground. To enlarge the credibility of the MAK report, Russian soldiers moved that portion westward with respect to the groove. This new position, registered later in aerial photograph, was already consistent with the MAK hypothesis. We have to emphasize that those grooves have no relation with the Smolensk Catastrophe of April 10, 2010, and have appeared in the terrain before the previous vegetation season, as is witnessed by their bottom covered by dry grass [22].

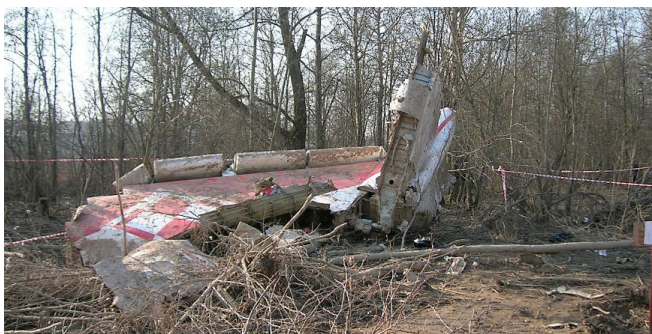
In this zone the rest of the vertical stabilizer has been found, with the fragments of the horizontal stabilizers visible (Fig. 23). It is peculiar that the place of its fall is just right behind the trees. This is why the visible damage cannot result from repeatedly striking the ground, the missing parts are absent in the local area.

Fig. 23. The rest of the tail fin (vertical stabilizer) and the adjacent portions of the horizontal stabilizers [6]. The missing part of the horizontal stabilizers dropped off earlier.

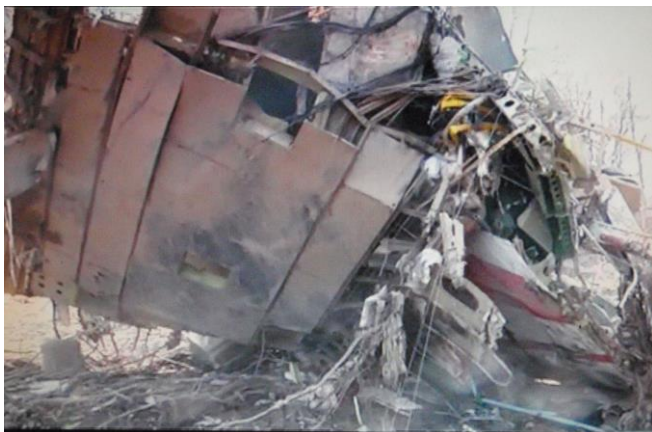
fuselage, but also caused a "blow-out" of its entire contents. As evidenced by Fig. 24 not only the passengers, but also all the seats, despite their solid attachment to the floor, have been blown out.

Fig. 24. The floor of the Tu-154M plane when lifting the fuselage [13]. Throwing out the sides and the ceiling of the torn fuselage (the later already turned upside down), led the fuselage to fall down in such a way that the floor was adjacent to the surface of the ground. However, during lifting the fuselage (shown in the photograph), one does not see neither the passengers' bodies nor even the seats. Only the floor rails for fastening the seats are visible.

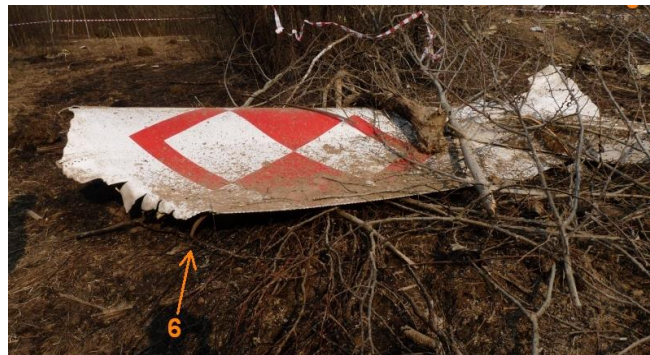
A separate issue represent the distant positions of both sides of the shells of the structures an aircraft is built of. For example, the left wing: both wing shells lie separately. This demonstrates the disruption of the structure that happened from its inside.

Fig. 25. The terminal part of the left wing (bottom shell) with the flap track fairings (6). In the background the right-hand-side horizontal stabilizer (3) [17]. The upper shell has been crushed and its pieces are in remote locations.

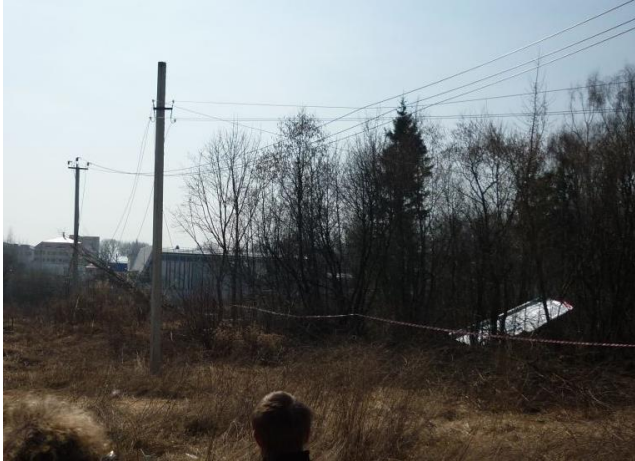
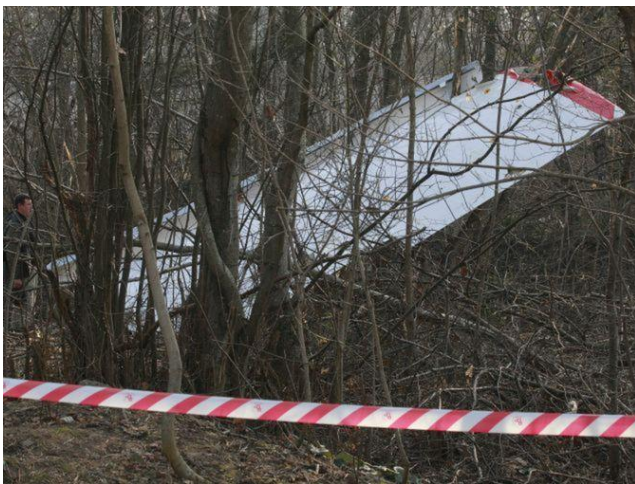
Many fragments lie in the middle of the trees, which proves that they can only be found there by a fall from an altitude larger than that of the treetops. The first such example is the terminal part of the left wing lying in zone B2 (Fig. 29). This fragment has been found in a spot surrounded by the trees higher than 10 m, with the crowns that are not damaged. Its location and the fact that it is stuffed into a thin tree proves that the fragment fell down vertically from an altitude higher than 10 m. This eliminates the possibility of its arriving there as a result of a mowing-like flight from the location of the "Bodin's birch."

Fig. 29. The tip of the left wing lying in the location that is surrounded on all sides by the trees of height larger than 10 m [19].

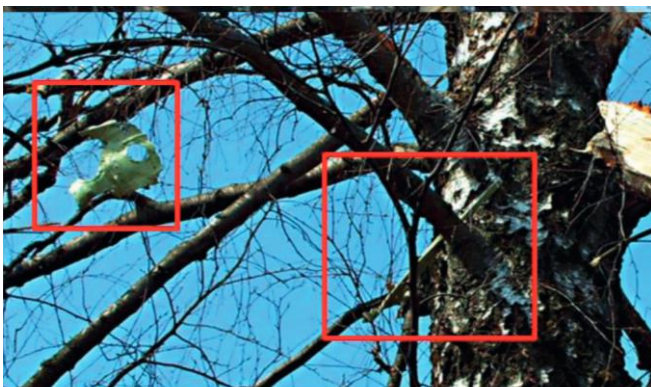
The "tin birds", Figs .30 , 31 , 32 , not only prove they broke off the aircraft above the location they were found hanging, but also witness they broke away from the aircraft at a distance of at least several tens of meters in front of the

Fig. 30. Fragments of the left wing on the Bodin birch at the altitude of the breakthrough [10]. "Tin birds" have been detached from the aircraft, not less than several dozen meters earlier and much higher than the points they have been settled on.

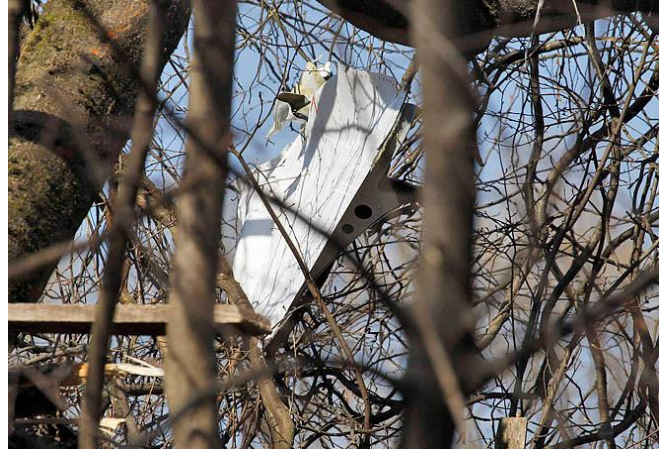
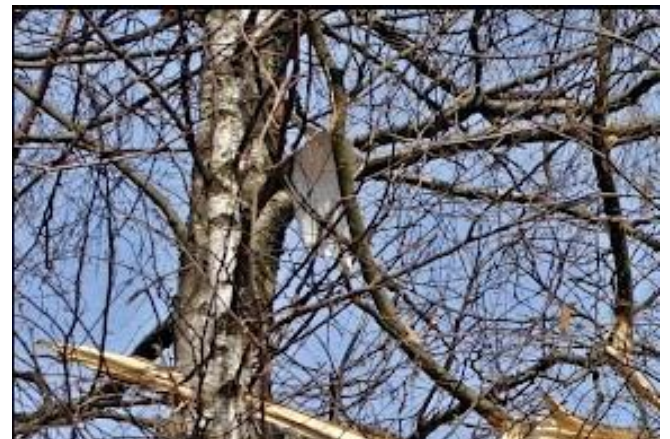
Fig. 31. "The tin birds" at Gubienko Street.

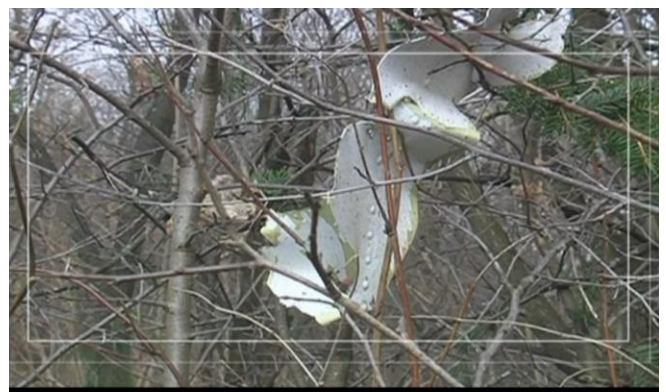
Fig. 32. A "tin bird" at Kutuzov Street [13].
