WHAT WE KNOW ABOUT THE COURSE OF THE SMOLENSK CATASTROPHE.

THE SMOLENSK CONFERENCES - A PRELIMINARY SUMMARY

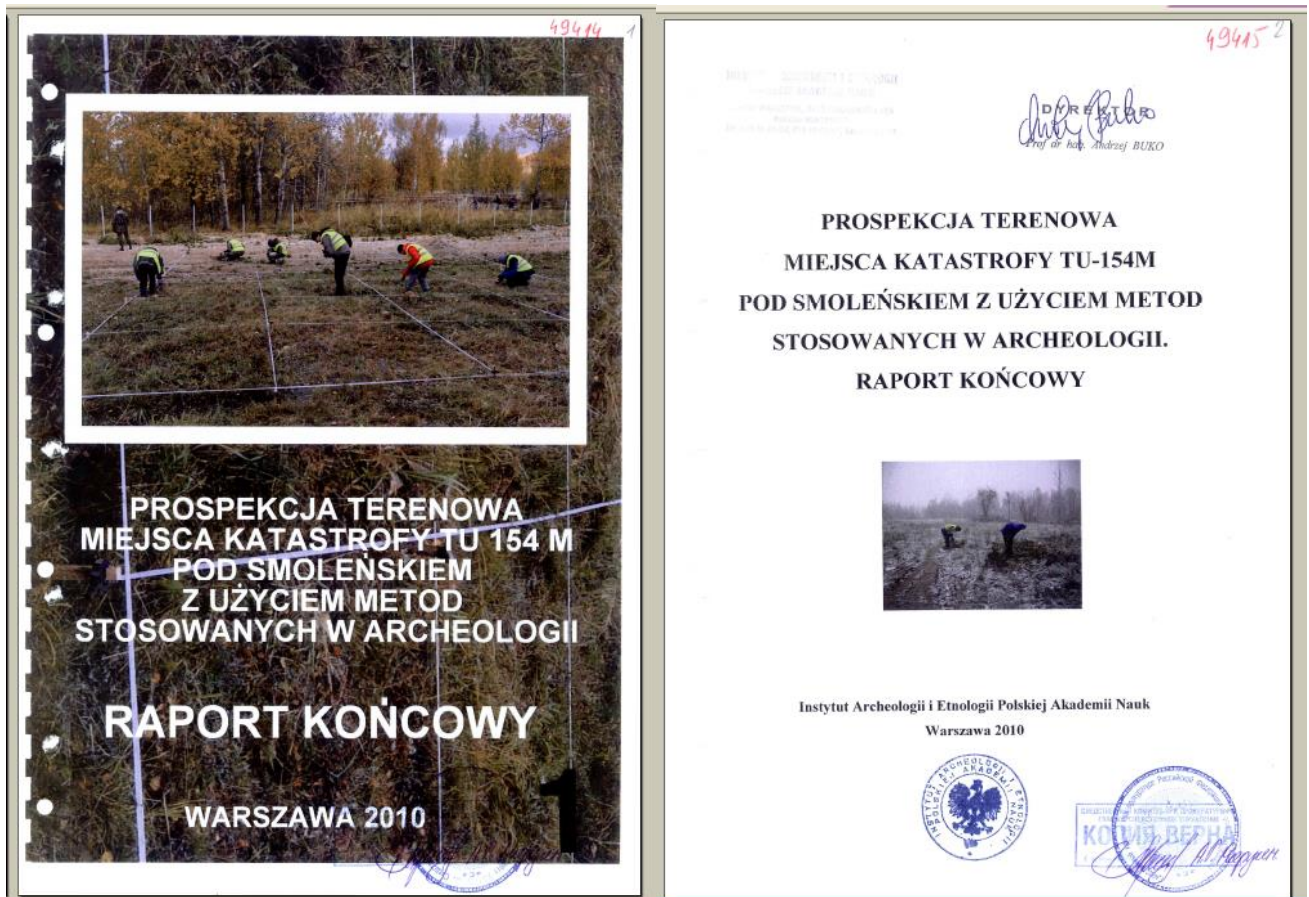
1. The report of the official team of the Polish archaeologists (Fig.1), who, after the official search already done, reinvestigated the crash site between October 13 and October 27, 2010 and have found some further 30 000 fragments. The team estimated the total number of fragments still hidden in the ground as 60 000. A part of the fragments found was situated before the location, which according to the MAK/Miller hypothesis was identified as the first contact of the plane with the ground. It should be stressed that among the fragments found in this spot, there were some human remains.

Fig. 1. The report of Polish archaeologists from the Institute of Archaeology and Ethnology of the Polish Academy of Sciences.

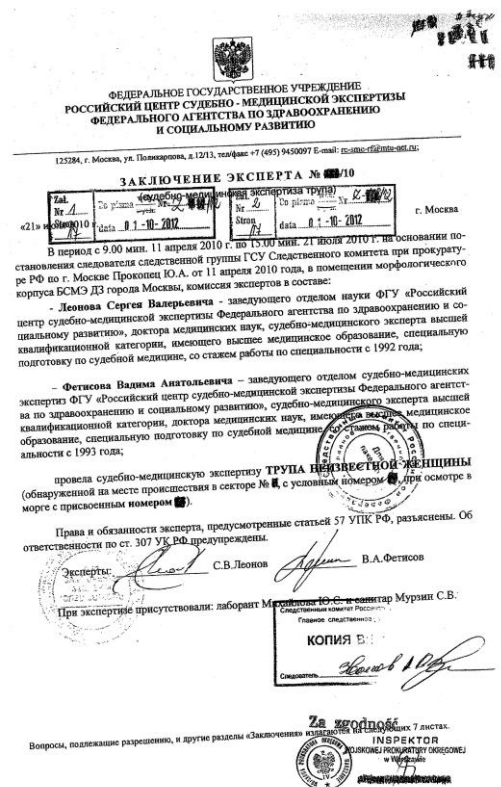
2. The forensic documents prepared for the victims by the Moscow Forensic Institute (Fig. 2). One should stress that the Polish experts, who arrived to Moscow on April 11, 2010, were not allowed to participate in victims' autopsies: "after arriving to Moscow on April 11, 2010 and transportation of the team to the forensic institute (arrival time not given) we were informed, that the autopsies of all the victims, that have been transported from Smolensk to Moscow till now, have been already performed by the experts of the Russian side" [4]. Moreover, it follows from these documents, that the inspection of the victims in the Catastrophe site began about 2 p.m. on April 10, 2010 and lasted, with variable inspection time, from four to six or more hours. Despite of this on April 11, 2010 all victims not only have been transported to Moscow, but according to the Russian side the autopsies were already over.

Fig. 2. The first page of a typical Russian forensic post-autopsy protocol. In the headline: "Federal State Institution. Russian Forensic Center of the Federal Health and Social Progress Agency

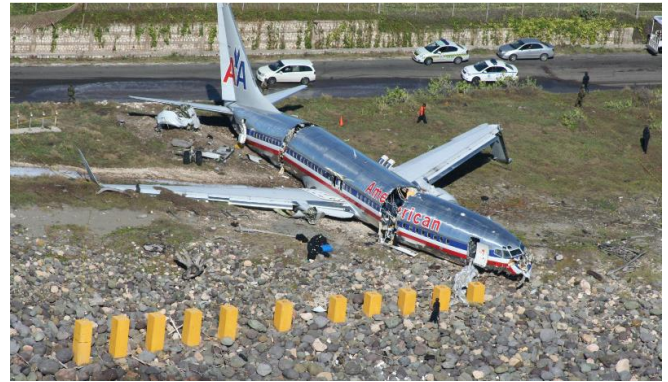
Fig. 7. The catastrophe of the Boeing 737-800 airplane in Kingston, Jamaica on Dec. 22, 2009. The catastrophe is of the 1A type -- the airplane hit the ground, no explosion.

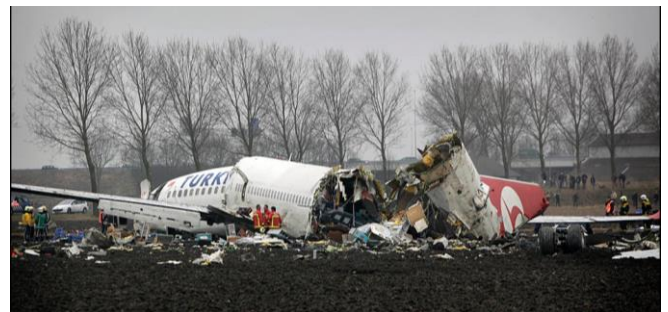
Fig. 8. The catastrophe of the Boeing 737-800 airplane in Amsterdam, The Netherlands on Feb. 25, 2009. The catastrophe is of the 1A type -- the airplane hit the ground, no explosion.

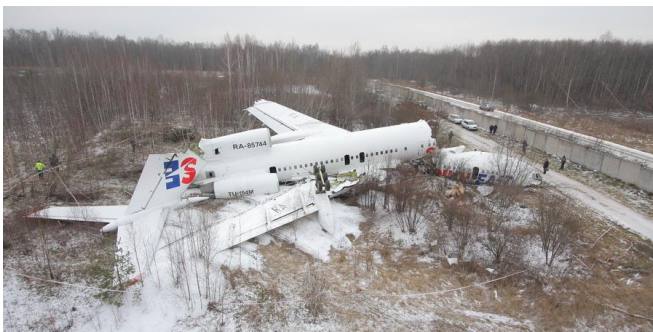
Fig. 5. The catastrophe of the Tu-154M airplane in Moscow on December 4, 2010. The catastrophe is of the 1A type -- the airplane hit the ground, no explosion.

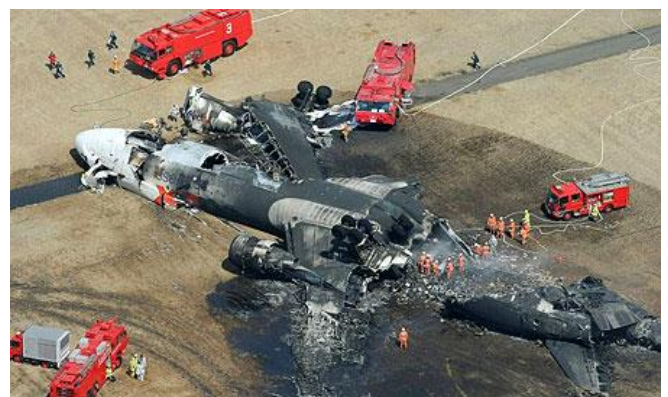
Fig. 9. The catastrophe of the MD-11 airplane in Tokyo, Japan on March 23, 2009. The airplane hit the ground, divided (perpendicularly to the airplane axis) into several segments. Then the plane exploded, the explosion occurred in the rear part, this part has been torn and opened longitudinally.

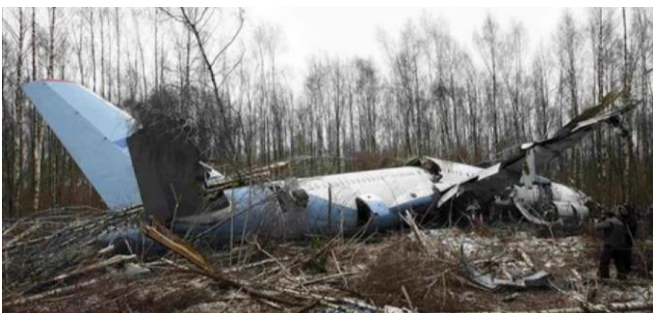
Fig. 6. The catastrophe of the Tu-204 airplane in Moscow on March 22, 2010. The catastrophe is of the 1A type -- the airplane hit the ground, no explosion.

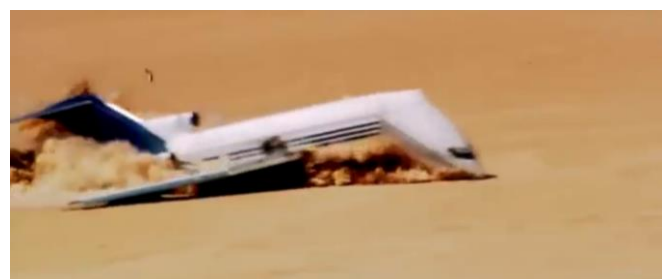
Fig. 10. The crash test with the Boeing 727-200 in desert (Mexico) on April 27, 2012. The movie shows the way the construction is crashed after hitting the ground [7].

One could see the very essence of the longitudinal cracking mechanism when studying hitting the ground during the crash experiment (2012) in the Sonora desert in Mexico (Fig. 10).

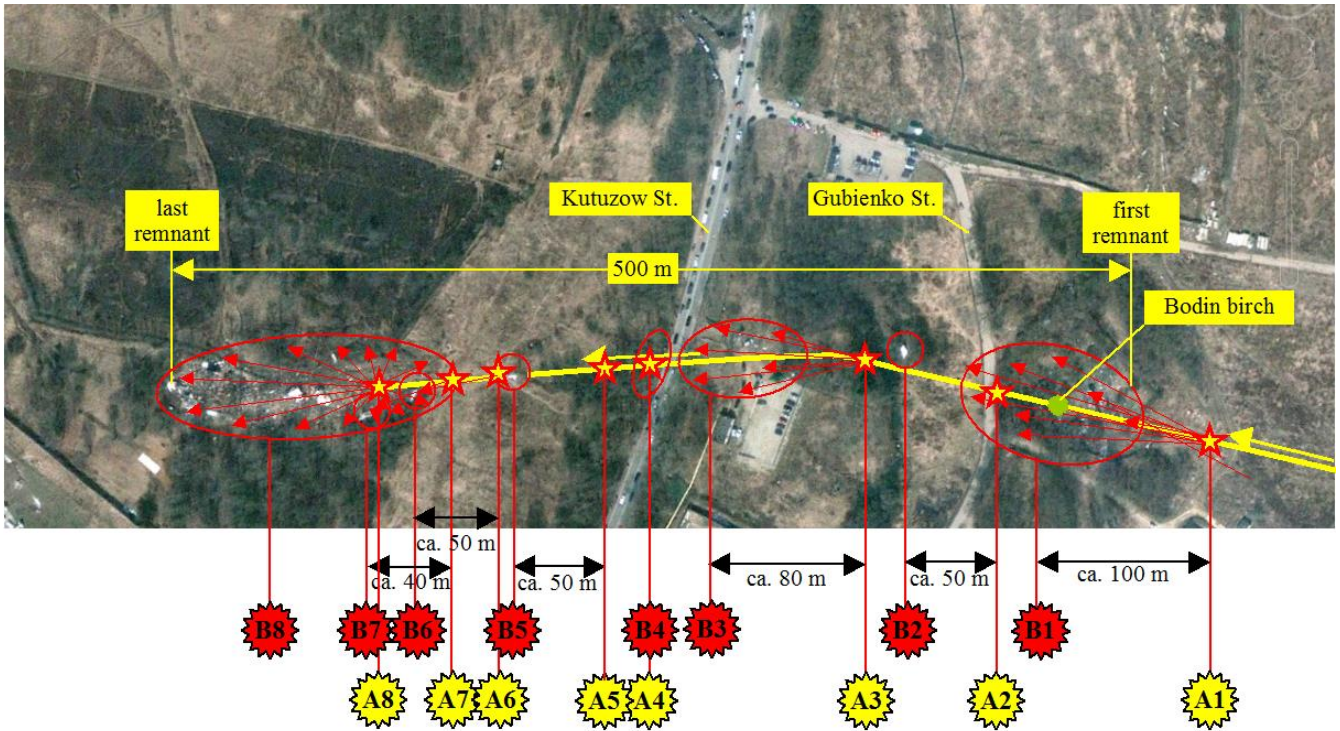
According to the archaeological report the Tu-154M aircraft has been disintegrated into about 60 000 fragments (educated estimation). The distribution of the main fragments can be divided into eight zones, shown in Fig.14. The distance between the first fragment found (several dozens of meters before the Bodin birch) and the last one spans the trajectory section of about 500 m long. These zones may be described as follows.

Fig. 14. The trajectory of the Tu-154M plane and the horizontal distribution of the main fragments. Letter B stands for showing the centers of the successive zones of the residual debris (remnants). Letter A indicates an approximate location of the corresponding point of detachment of the fragments from the aircraft structure, the later moving at a speed of about 270 km/h.
